**Flood Control Project Maintenance
Levee Inspections**
LMA District Cover Sheet
Spring 2010 Levee Inspection Results

Reclamation District No. 2075 McMullin

Spring 2010 Levee Inspection Results

Waterway			Bank	Unit Miles
Unit No. 01 San Joaquin River			Right	7.52
	Spring (March - May)	Summer (June - August)	(September - November) Fall	Winter (December - February)
Unit Maintenance Rating (Fall Only)				
Date of Inspection	4/7/2010 - 4/7/2010			
DWR Inspector	Herman Phillips			
Accompanied By	Mr. Eddie Cordoza Reclamation District 2075

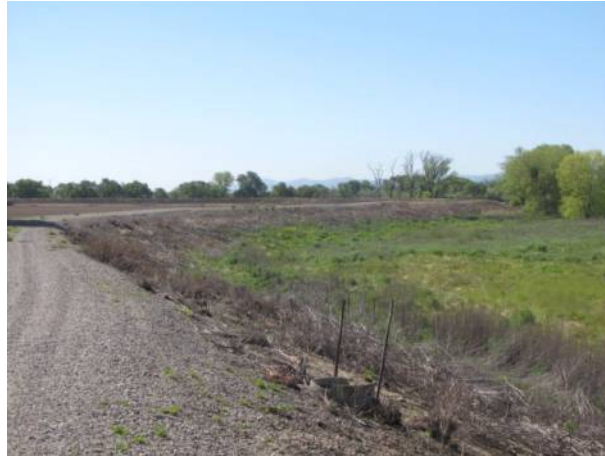
phillips_s_20100622_093.jpg

Levee Mile Report Line	1
Start Levee Mile	0.08
End Levee Mile	0.08
Location	Water Side
Category	Earthen Levee
Item	Vegetation

Levee mile 0.08 standing on waterward side looking downstream of district, there is no grassed on the leve slope, the Maintaining Agency sprayed the slopes. The land side slope looks the same.

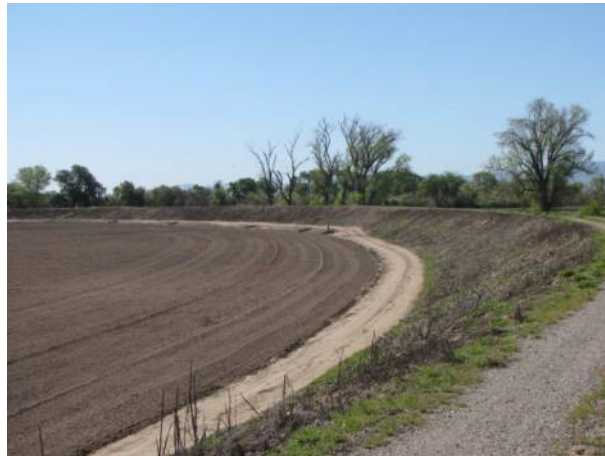
phillips_s_20100622_094.jpg

Levee Mile Report Line	1
Start Levee Mile	0.08
End Levee Mile	0.08
Location	Water Side
Category	Earthen Levee
Item	Vegetation

Standing on landward side looking downstream from levee mile 0.08 levee slopes looking good.

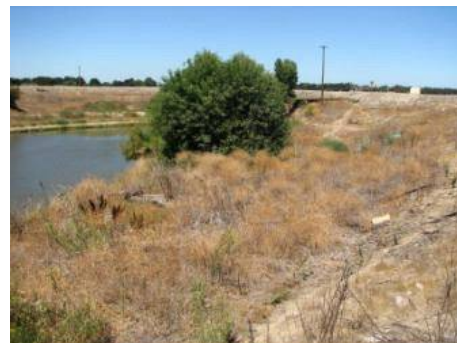
SJR2009_RM64.34a.JPG

Levee Mile Report Line	9
Start Levee Mile	5.34
End Levee Mile	5.35
Location	Water Side
Category	Supplemental
Item	DWR Erosion Survey

2009: No major change; located in an oxbow; slope surface consist of very sandy material; exposed tree roots; recommend as a local maintenance issue, per CLRO CES Evaluation 2008 Report; Eddy Cordoza of RD 2075 is aware of the site; previously rated "U" [2009 SiteID:RD2075U1RM64.34]

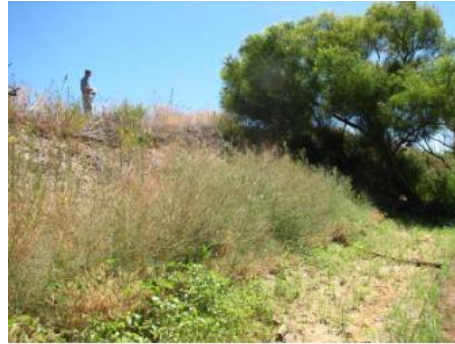
Levee Mile Report Line	9
Start Levee Mile	5.34
End Levee Mile	5.35
Location	Water Side
Category	Supplemental
Item	DWR Erosion Survey
<p>2009: No major change; located in an oxbow; slope surface consist of very sandy material; exposed tree roots; recommend as a local maintenance issue, per CLRO CES Evaluation 2008 Report; Eddy Cordoza of RD 2075 is aware of the site; previously rated "U" [2009 SiteID:RD2075U1RM64.34]</p> <p>SJR2009_RM64.34f.JPG</p>

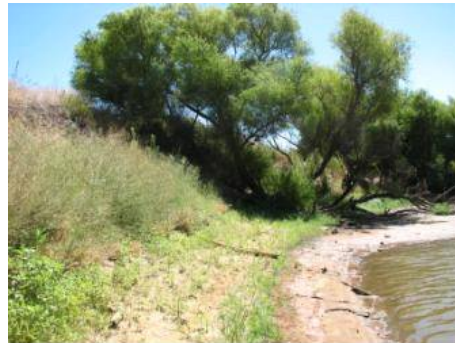
Levee Mile Report Line	9
Start Levee Mile	5.34
End Levee Mile	5.35
Location	Water Side
Category	Supplemental
Item	DWR Erosion Survey
<p>2009: No major change; located in an oxbow; slope surface consist of very sandy material; exposed tree roots; recommend as a local maintenance issue, per CLRO CES Evaluation 2008 Report; Eddy Cordoza of RD 2075 is aware of the site; previously rated "U" [2009 SiteID:RD2075U1RM64.34]</p> <p>SJR2009_RM64.34g.JPG</p>

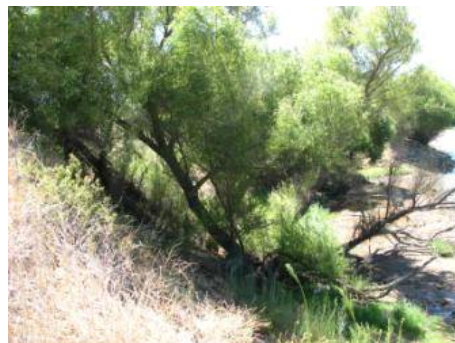
Levee Mile Report Line	9
Start Levee Mile	5.34
End Levee Mile	5.35
Location	Water Side
Category	Supplemental
Item	DWR Erosion Survey
<p>2009: No major change; located in an oxbow; slope surface consist of very sandy material; exposed tree roots; recommend as a local maintenance issue, per CLRO CES Evaluation 2008 Report; Eddy Cordoza of RD 2075 is aware of the site; previously rated "U" [2009 SiteID:RD2075U1RM64.34]</p> <p>SJR2009_RM64.34d.JPG</p>
